A FLIGHT TEST EVALUATION OF THE SINHA WING PERFORMANCE ENHANCING DETURBULATORS

Richard H. Johnson 1/2/07

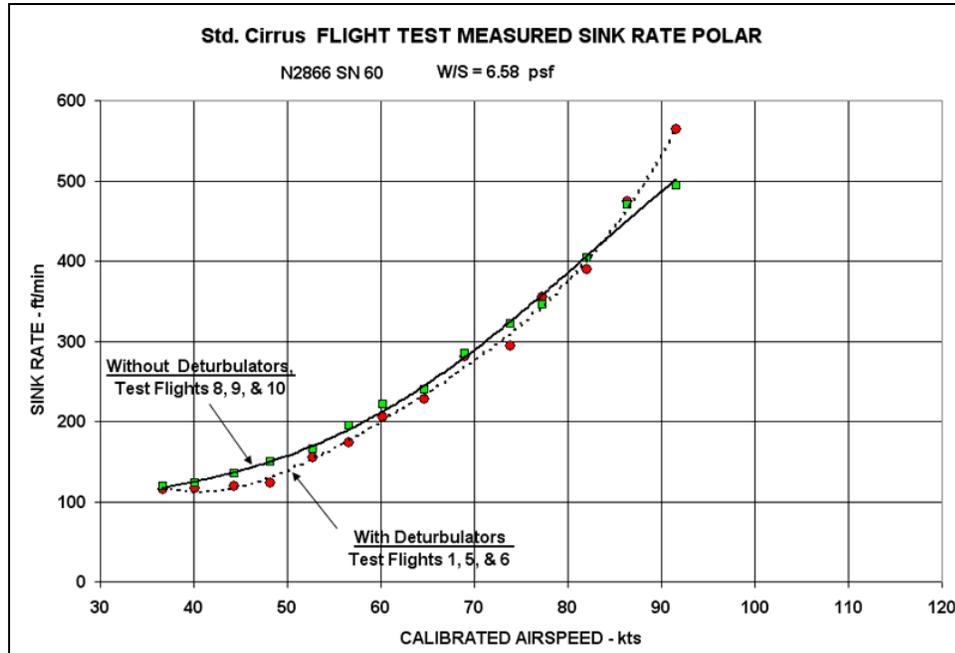
test data from those 3 test flights show considerably less data scatter than did Flights 2, 3, & 4. Figure 6 shows the averaged sink-rates measured during the selected 3 deturbulated-wing test flights. Figure 7 shows their corresponding L/D ratios. Also shown in both figures, for comparison, are the test data for the deturbulator-removed test flight data.

Figure 6. Average Sink-Rate Data for Flights 1, 5 & 6

Those test data indicate that the deturbulators improved the Std. Cirrus best glide performance from about 33.5:1 at 44 kts, to about 38:1 at 46 kts; an improvement of about 13% in L/Dmax. These numbers are again derived from a 4th order trend-line drawn through the less-scattered test data points. The many-point averaged deturbulated wing test data at 48 kts still

shows a well-above trend-line L/D point of almost 40:1, an improvement of about 18% over that of the clean-wing data. The above-90 kt data with the deturbulators still showed a slightly higher drag than with the clean wings.

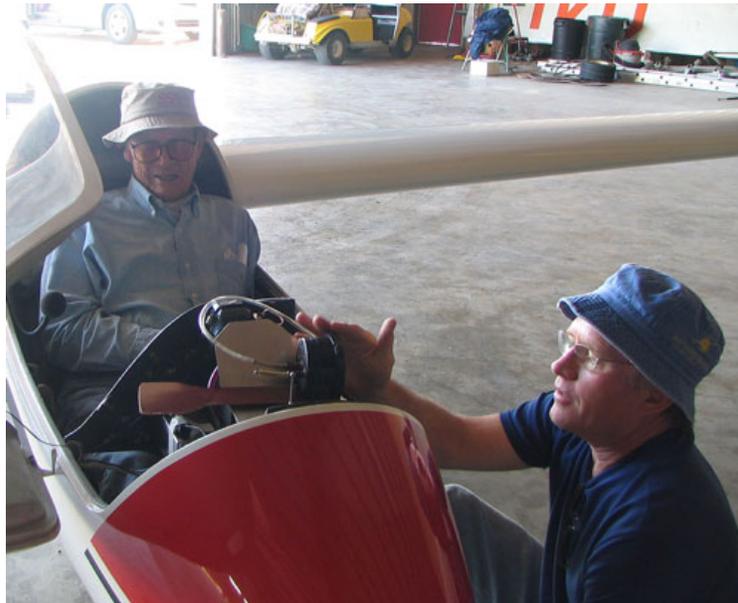
Figure 10. Dick Johnson and Jeff Baird calibrating the airspeed indicator
